# Finding space for water - River Irk, Alkrington

Environment Agency  
Mersey Basin Rivers Trust

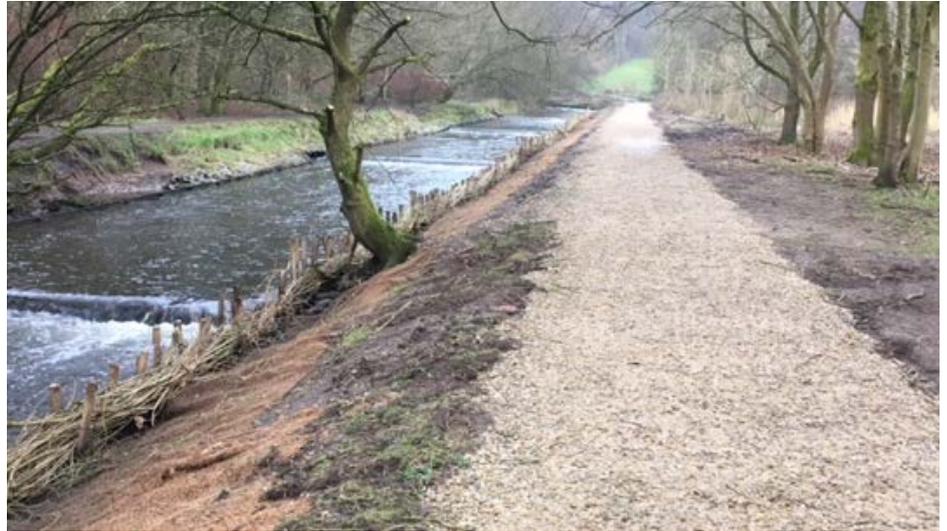
Above: Softened banking

- **Channel improvements:** The notches in the weirs have improved flow diversity of the channel. The lowering of the banking was limited due to the constraints, however, the hard banking has been removed and brash bundles and coir matting to protect the new re-profiled bank. Over time, we expect the channel to widen as silt and sediment is deposited behind the brash bundles.

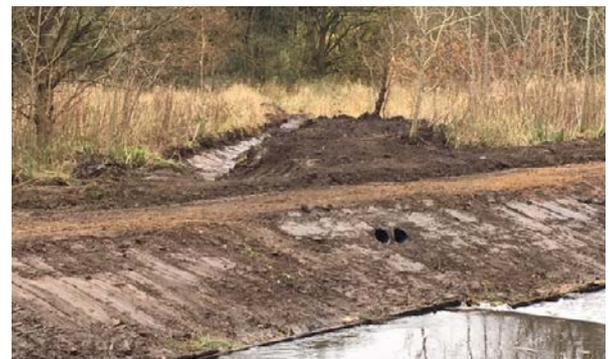
Above: River Irk – off-take to wet grassland

- **Connection to the flood plain:** This was achieved by using pipes under the footpath to take high flows into two areas - one a natural low lying area and the second old mill lodges.
